Appendix M

Ecological Risk Assessment Report

Attachment 1
Site Visit Eco-Checklist

1. Site Name: Omega Site OU2

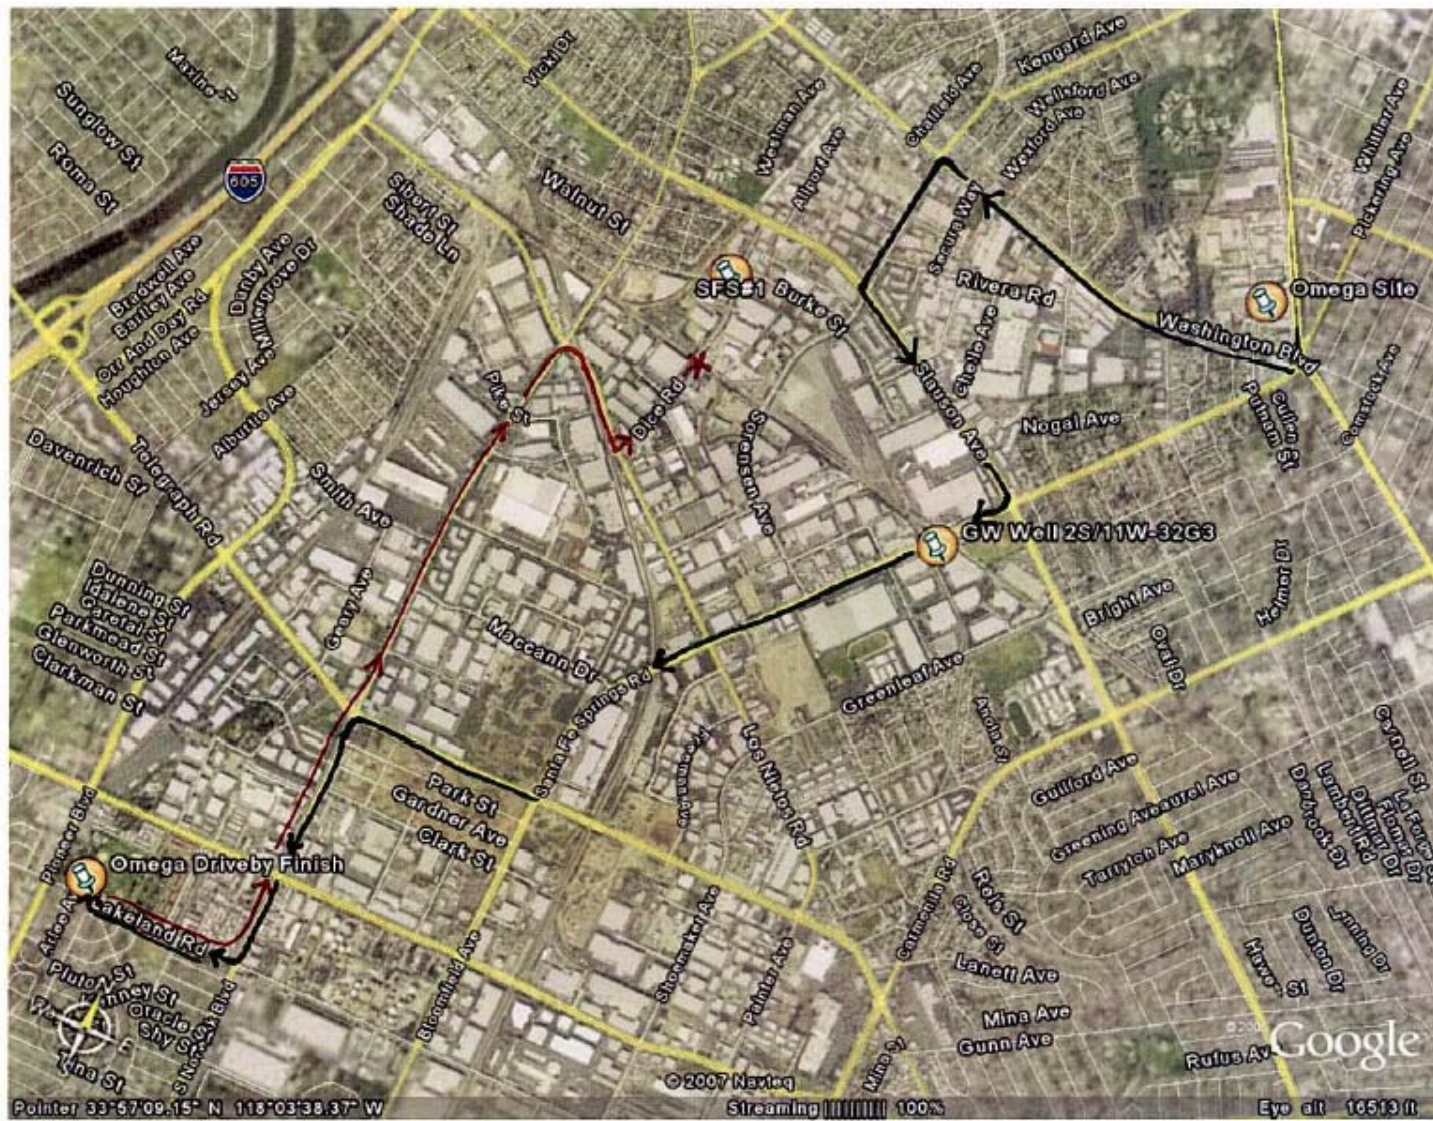
Site visit windshield tour route across OU2.

→ Initial drive across Omega on 2

→ Return across our 2 to point of interest (McKesson/Angeles GW treatment)
